Adaptive Reuse of the Stoughton 1892 High School

Alex Buckmann,
Andrew Rexrode
Elizabeth Rubenzer
Ryan Michuda
Stefan Donica
Stephany Siu Perez

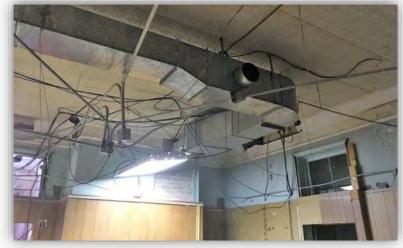
Exposed framing and wiring

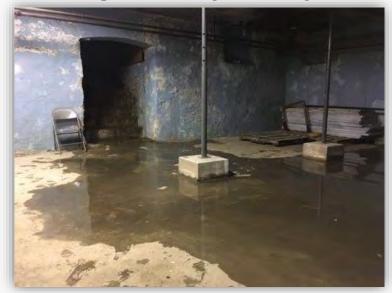
Flooding and storm water management issues

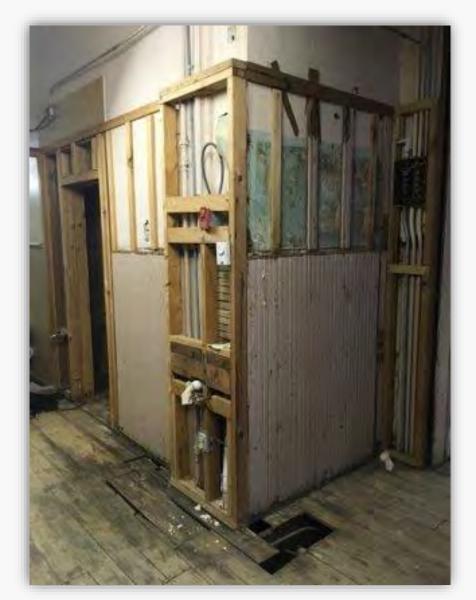
3rd Floor / Attic Space

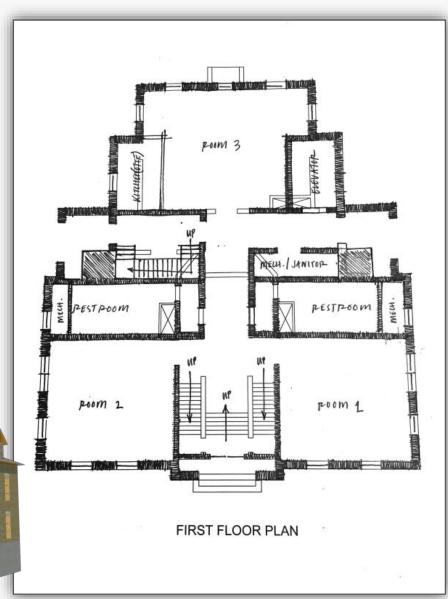
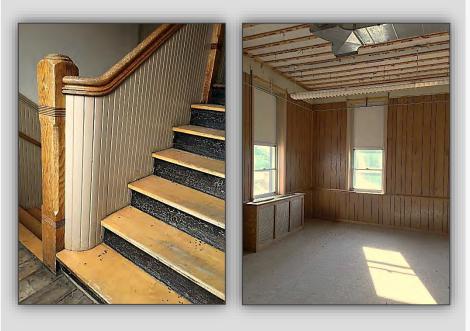
SELECTIVE

Minimize overall building remodeling costs by only including necessary remodel work.

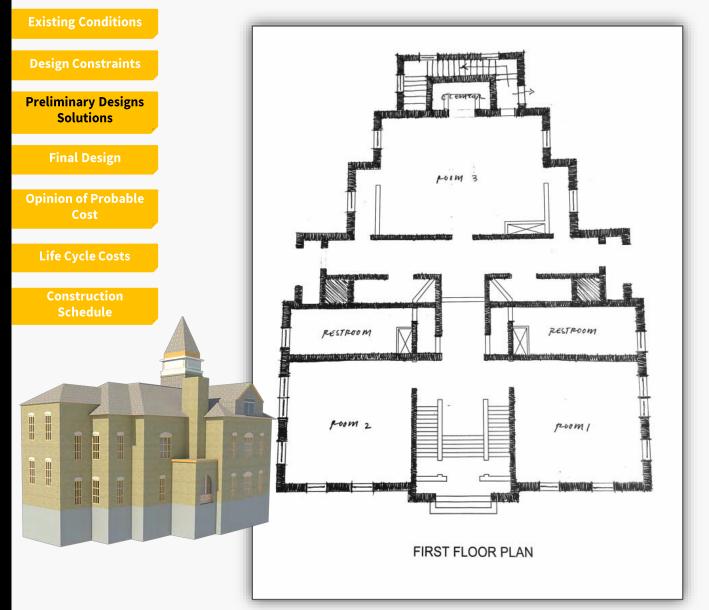
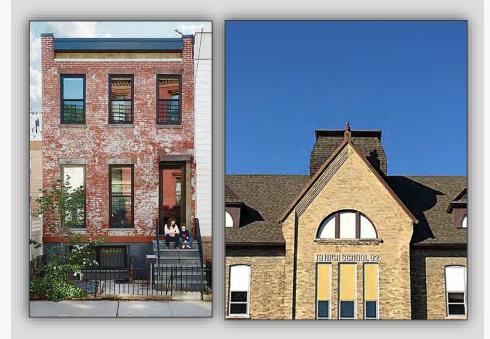
INTERMEDIATE

Perform complete remodel of all building spaces.

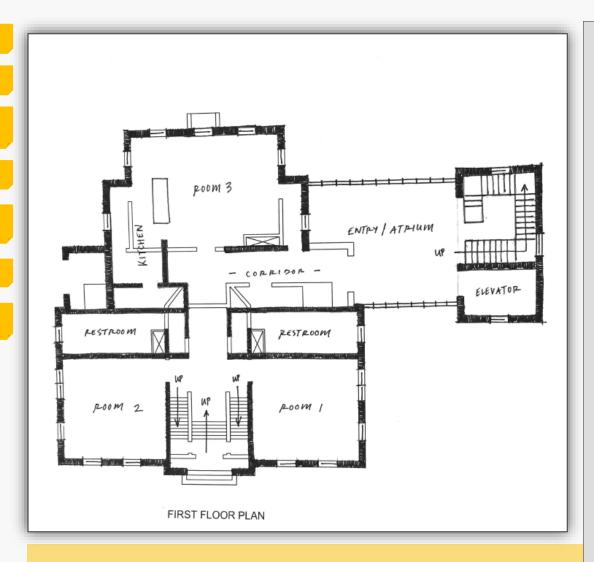
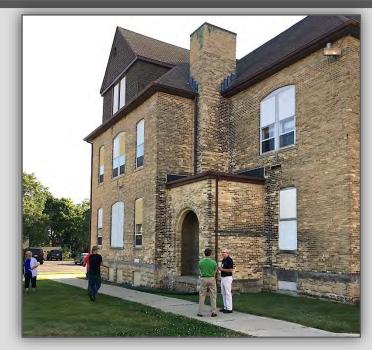
COMPREHENSIVE

Incorporate modern addition that respects the existing Romanesque Revival Architecture.

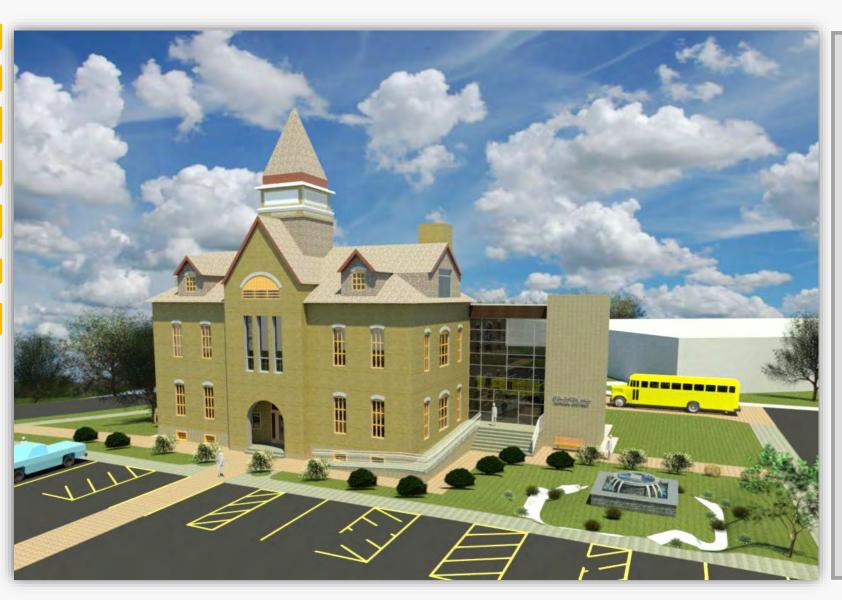
EXISTING SQUARE FOOTAGE

13,000

ADDITION SQUARE FOOTAGE

5,000

TOTAL SQUARE FOOTAGE

18,000

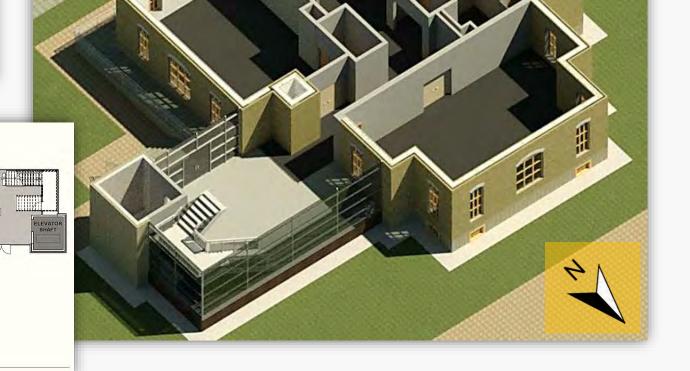
First Floor – Interior Aerial View

(sheets) SCHEME - REHAB - Level 1

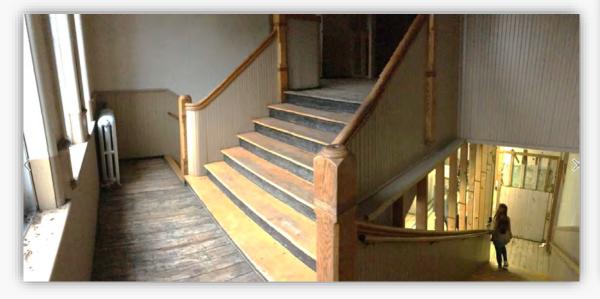
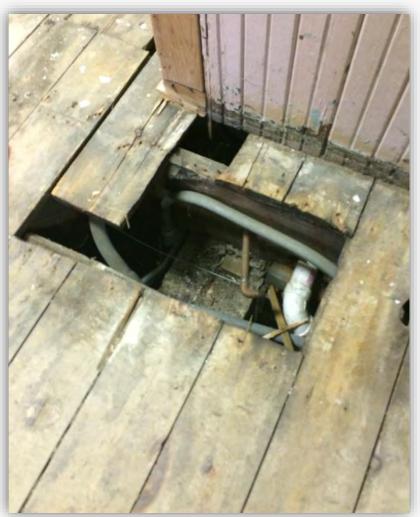
- Beam Dimensions
- Material Type

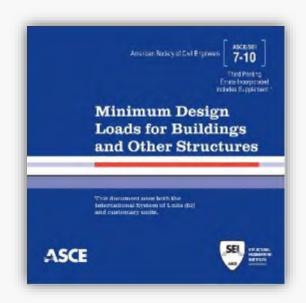
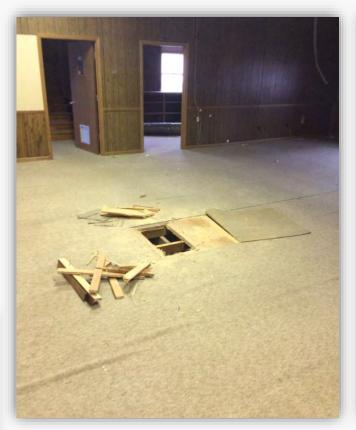
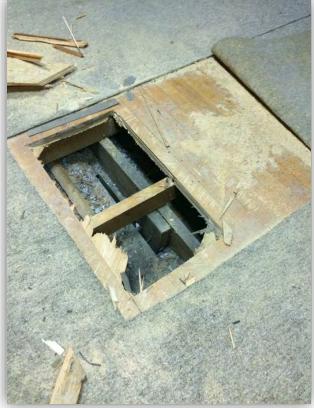
Required Live Loads				
Occupancy	Uniform (psf)	Concentrated (lb)			
Computer Lab	100	2,000			
Lobbies	100				
Stage	150				
Corridors	100				
School Classroom	40	1,000
